DEPARTMENT OF TRANSPORTATION**DIVISION OF ENGINEERING SERVICES**

Contract #: 04-0120F4Cty: SF/ALA Rte: 80 PM: 13.2/13.9File #: 99.28**WELDING INSPECTION REPORT****Resident Engineer:** Casey, William**Address:** 333 Burma Road**City:** Oakland, CA 94607**Report No:** WIR-030057**Date Inspected:** 17-Sep-2013**Project Name:** SAS Superstructure**OSM Arrival Time:** 700**Prime Contractor:** American Bridge/Fluor Enterprises, a JV**OSM Departure Time:** 1730**Contractor:** American Bridge/Fluor Enterprises, a JV**Location:** Job Site**CWI Name:** Bernie Docena, Tony Sherwood**CWI Present:** Yes No**Inspected CWI report:** Yes No N/A**Rod Oven in Use:** Yes No N/A**Electrode to specification:** Yes No N/A**Weld Procedures Followed:** Yes No N/A**Qualified Welders:** Yes No N/A**Verified Joint Fit-up:** Yes No N/A**Approved Drawings:** Yes No N/A**Approved WPS:** Yes No N/A**Delayed / Cancelled:** Yes No N/A**Bridge No:** 34-0006**Component:** SAS Tower**Summary of Items Observed:**

Tower Skirt: Skirt Plate #2, Weld Jt's #157 south shaft, #156 north shaft, #157 west shaft

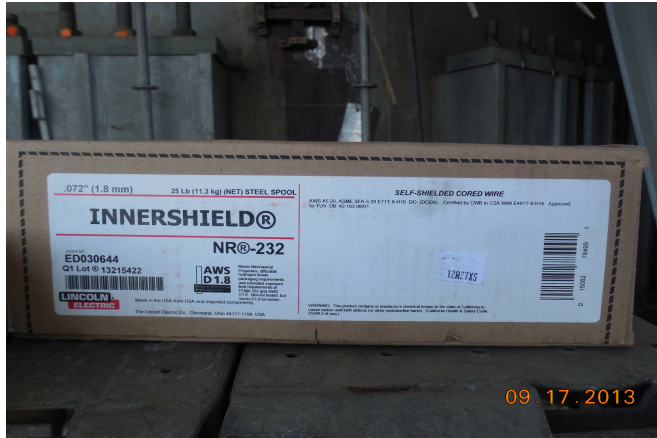
ABF personnel continued fit-up and welding of each vertical PJP splice weld noted above, at skirt plate #2. The welding procedure specification (WPS) #ABF-WPS-D15-2140-3 for flux core arc welding (FCAW) was available for reference on site by QC Inspectors and welders. QC Inspector verified joint fit-up and pre-heat. QC Inspector verified electrical welding parameters at the start of shift and randomly until the end of shift. Root passes of the welds above were magnetic particle tested (MT) by QC. The root pass, intermediate pass and weld cover passes were installed in the groove on the exterior face. At locations where the root gap exceed 5mm and up to 8mm maximum the contractor utilized steel backing (12mm x 38mm), please reference RFI# ABF-RFI-003417R02. Welding of vertical weld joint 156 north shaft, 157 south shaft and 157 west shafts was completed. Weld crowns still need to be ground flush or contoured.

- The weld joint fit-up and alignment was check with a straight edge and bridge cam gauge.
- Preheat was performed by rosebud torch and verified with temperature stick (200°F).
- Welding was performed by approved welders (Rick Clayborn, Kit Li)
- The weld Procedure and joint details FWT19 & FWT21 are for a partial joint penetration (PJP) weld.
- FCAW electrode used is NR-232, .072" diameter.
- Weld passes were de-slagged by grinder and wire wheel.

Skirt splice, electrode NR-232, .072" diameter.

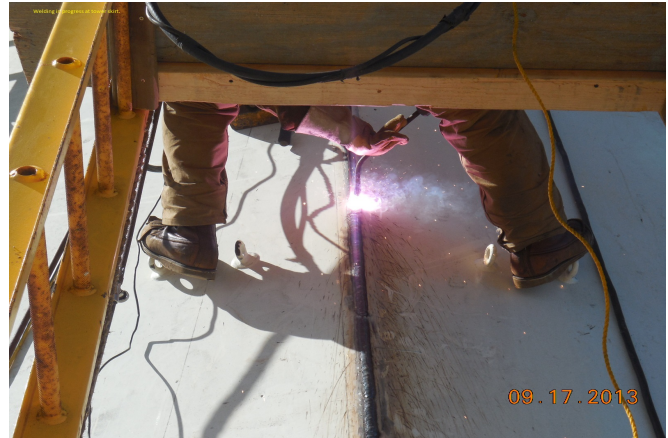
In process welding 3G splice weld at tower skirt.
